Lymington Harbour Commissioners

Beneficial Use of Dredged Sediment to Improve Boiler Marsh, Lymington

Review of restoration activities and monitoring undertaken for the first trial campaign in 2024

February 2025

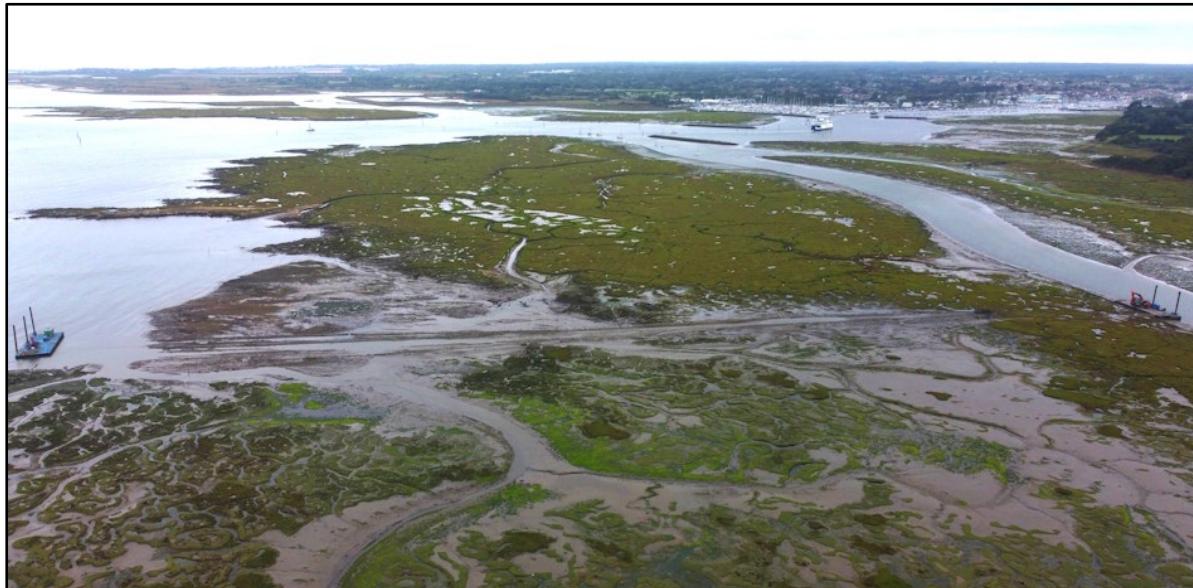
Image 2. Central and west side of Boiler Marsh during the drag box activities

For this first campaign the sediment movement was done using a new Saltmarsh Restoration Drag Box (SRDB) technique. This technique involves drawing a steel 'drag box' with load bearing skis along a winch line from the low to the high shore. The winch line is held between pulleys on a spud barge moored temporarily to seaward of the dredge sediment placement area and an excavator positioned on the landward side of the receiving/restoration site (see Image 2).

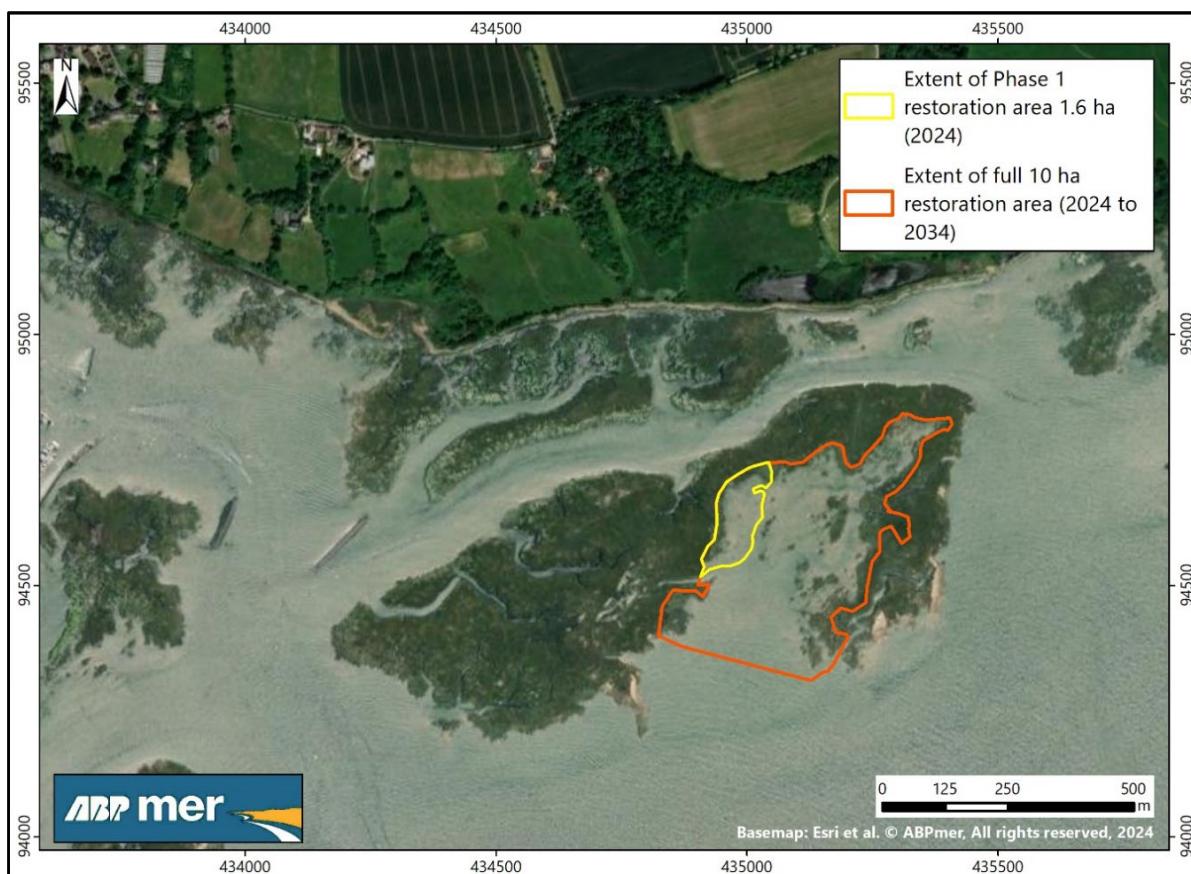
Figure 3. Extent of the Boiler Marsh restoration areas

As required under this agreed monitoring plan, this report is an end of calendar year review that describes the results of survey work undertaken before, during and after the 2024 campaign. It also outlines some of the key the lessons learned from this first phase of work. The location of this Phase 1 restoration area for the 2024 campaign is shown in Figure 3.

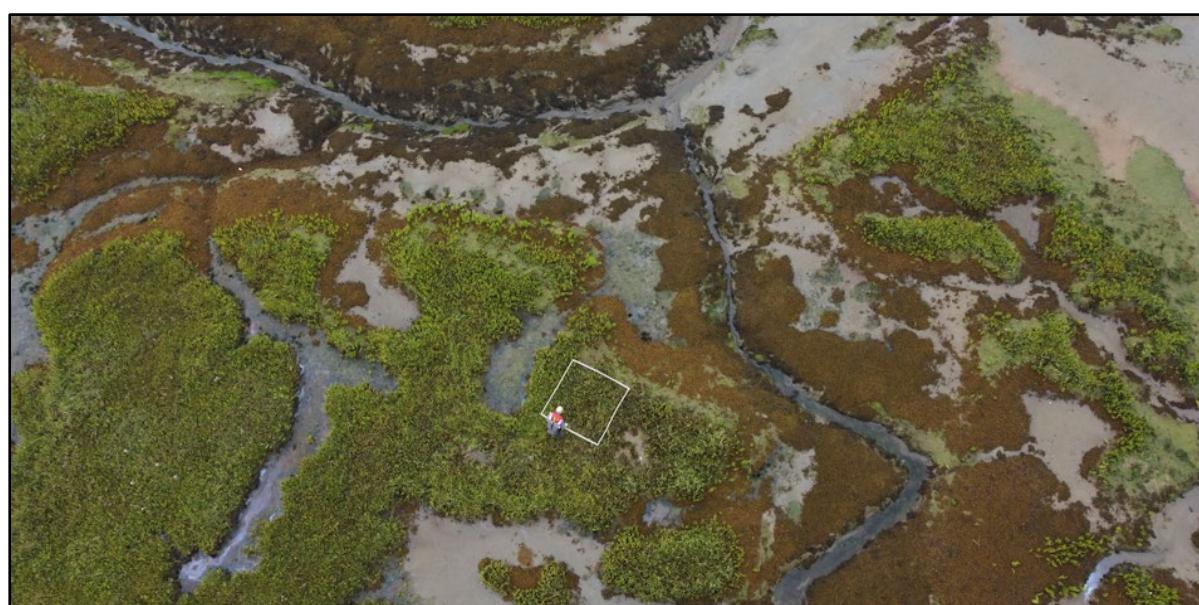
Image 3. Aerial view of 4 m² quadrat site for recording saltmarsh plant cover

During this survey, the percentage cover of marsh plants was recorded at the six established quadrat recording locations (Sites Q2 to Q7). An example of one quadrat sampling site is shown in Image 3; and the site locations are illustrated in Figure 5.

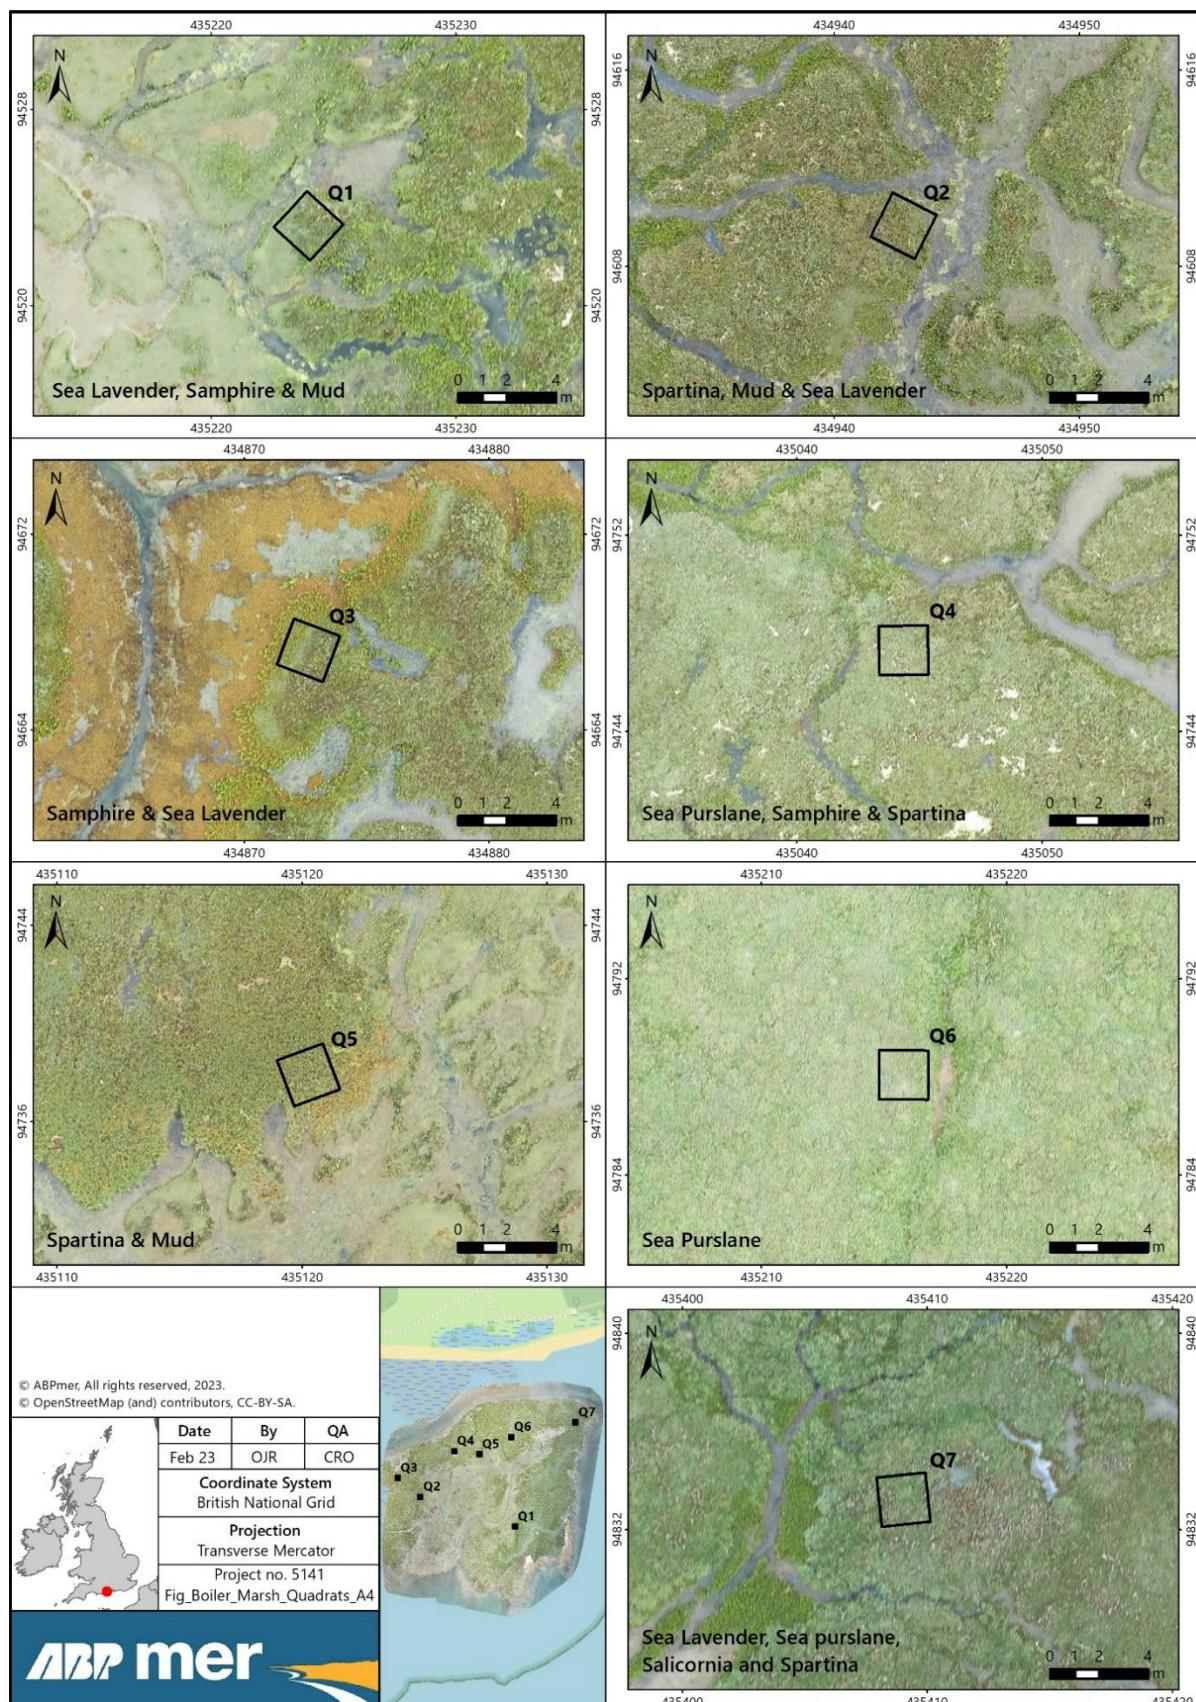
Figure 5. Quadrat site positions with aerial imagery showing habitat types (July 2022)

To further illustrate the baseline conditions across these sites and the areas surrounding them, Figure 5 reproduces a plot from ABPmer (2023) review. This figure shows the quadrat locations over a detailed aerial drone survey image taken that was also taken (by ABPmer for LHC) during summer 2022.

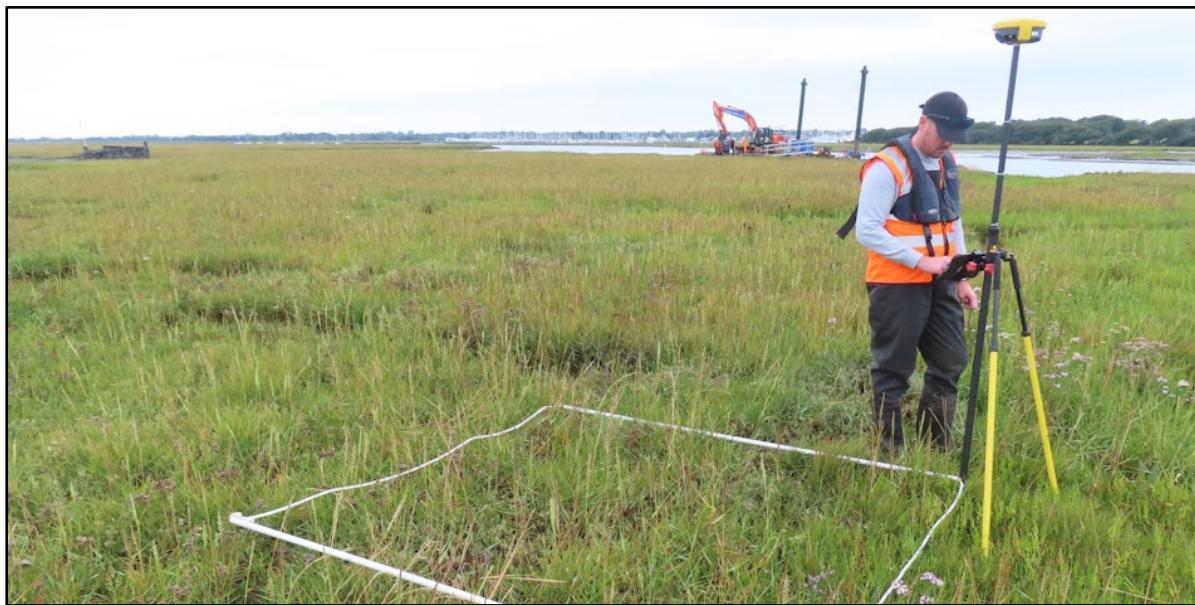
Image 4. Position and elevation recording of corners at quadrat Site Q4

At these six quadrat locations, a record was taken of percentage cover of each plant species present. Also, the position and bed elevation of each quadrat corner was taken using RTK GPS (see Image 4). These RTK measurements provide information on the range of bed elevations at each site and will also be used in future years to both record and accurately relocate the quadrat locations.

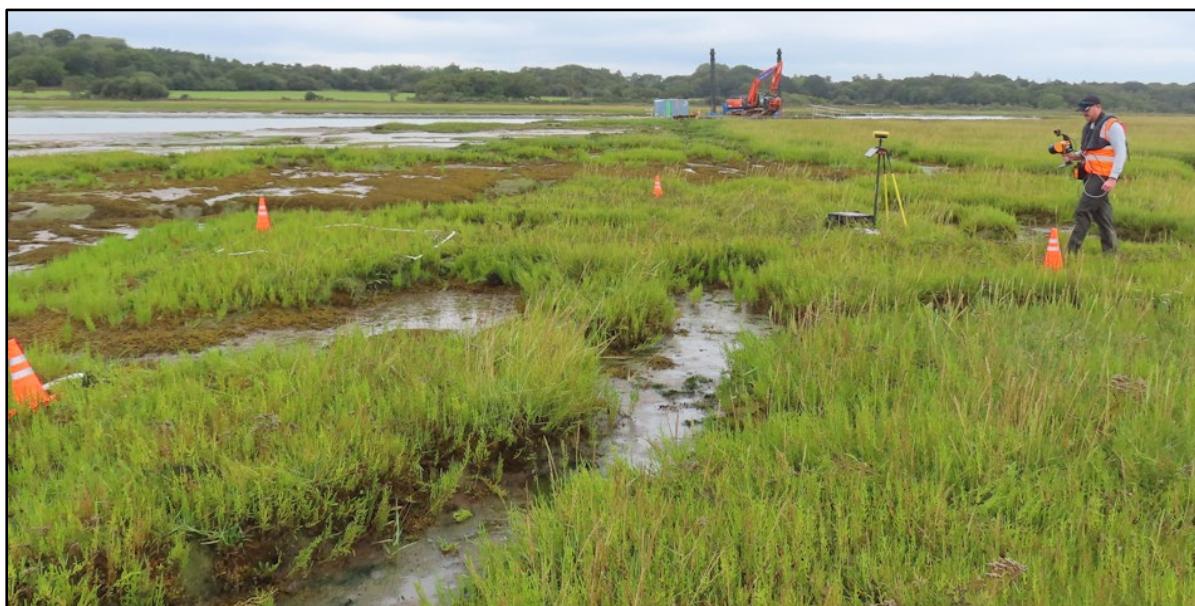
Image 5. GeoSLAM 3D LiDAR topography and photogrammetry mapping at Site Q3

using a GeoSLAM 3D Light Detection and Ranging (LiDAR) and photogrammetry scanner (see Image 5). These extra GeoSLAM readings were taken, in large part, to explore the value of using this approach on saltmarsh habitats.

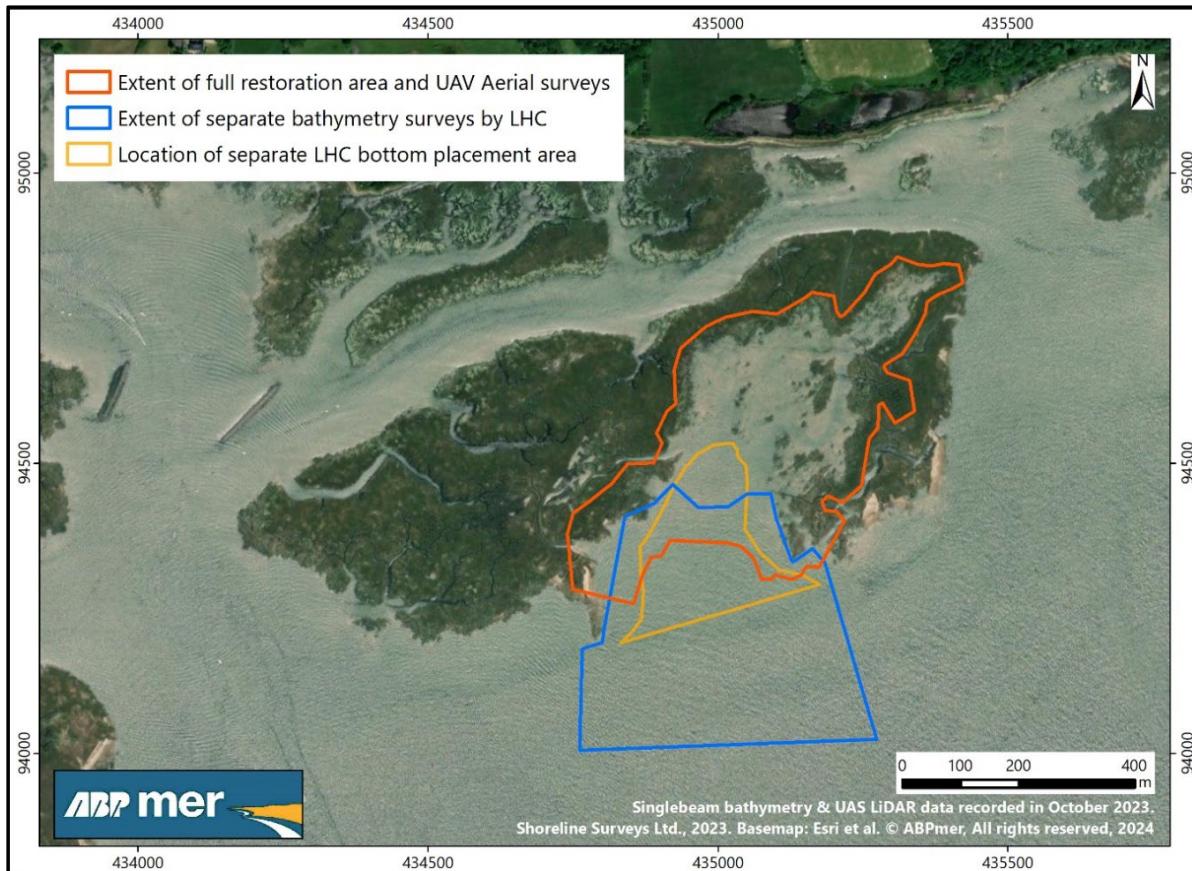
Figure 6. Areas covered by the topography and bathymetry surveys

Shortly after the restoration work was completed, Shoreline Surveys Ltd carried out combined bathymetry and aerial/drone topographic surveys of the site to describe the bed elevations across the restoration area. These surveys were undertaken on 2 October 2024 to describe the changes in intertidal elevations following the 2024 campaign (as required under the monitoring plan that was issued in fulfilment of Condition 5.2.19).

The areas covered by these bathymetry and topography surveys encompassed both the dredge sediment placement site from which sediment was excavated and the restoration area where this sediment was moved to. These areas are shown in Figure 6 alongside the area which is licensed for separate bottom placement.

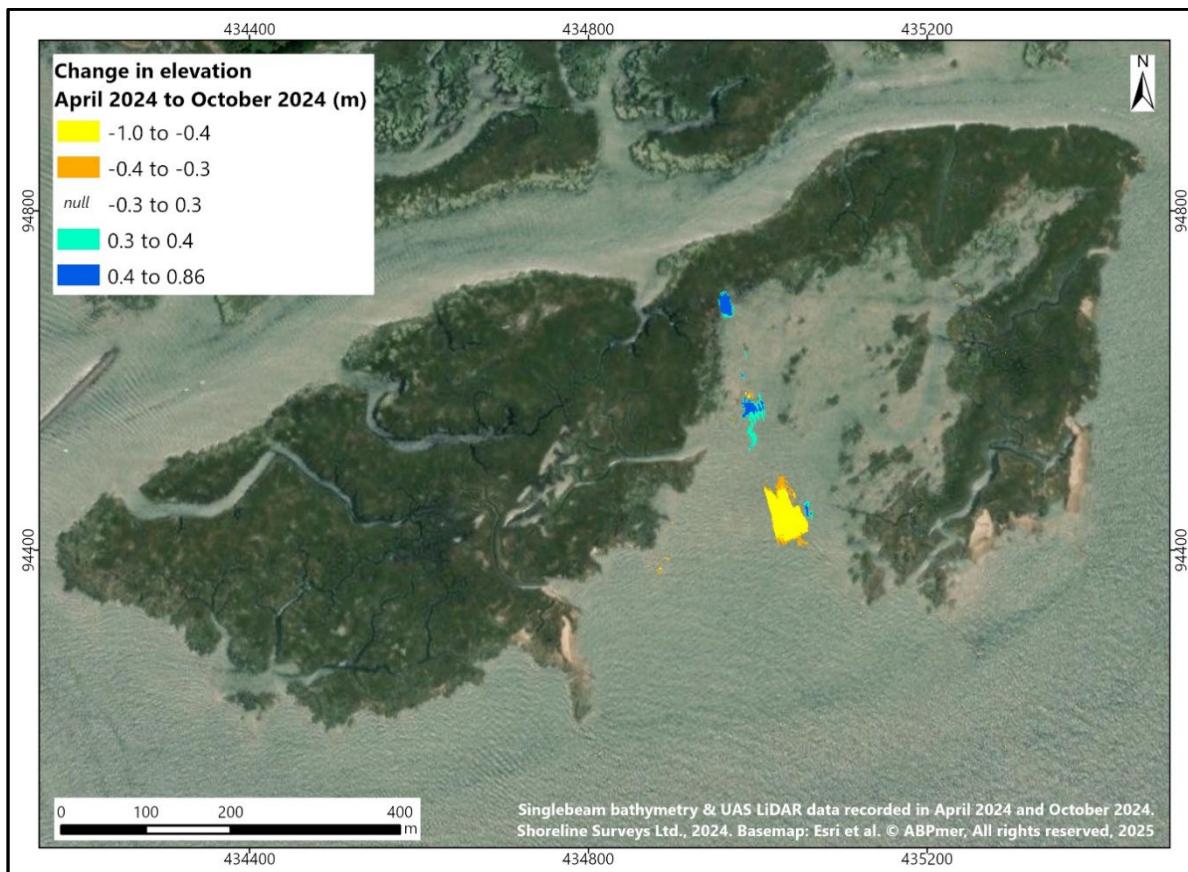
Figure 8. Changes in bed elevation across restoration site between April and October 2024

At the new bed elevations achieved on the northernmost area, marsh plant recolonisation may well now take place. It is less likely to occur at the southernmost area because of its lower elevation combined with greater wave exposure. However, in the weeks and months since the work was completed, the placed sediment in both areas will have settled, compacted and lowered in elevation. They will also have been affected by the winter storms over subsequent months. The extent of this settlement, and the level of initial plant colonisation will be explored during the 2025 monitoring campaign.

In conclusion, although the trial successfully increased the elevation of poor-quality marsh, the restored area was significantly smaller than was hoped for with the trial highlighting both the benefits and potential of the new technique, but also the challenges of habitat restoration in the marine environment. From this trial several important lessons were learned which will now be taken forward to refine and develop the equipment, work methodologies and the MMO marine licence parameters to enhance outcomes for future projects.

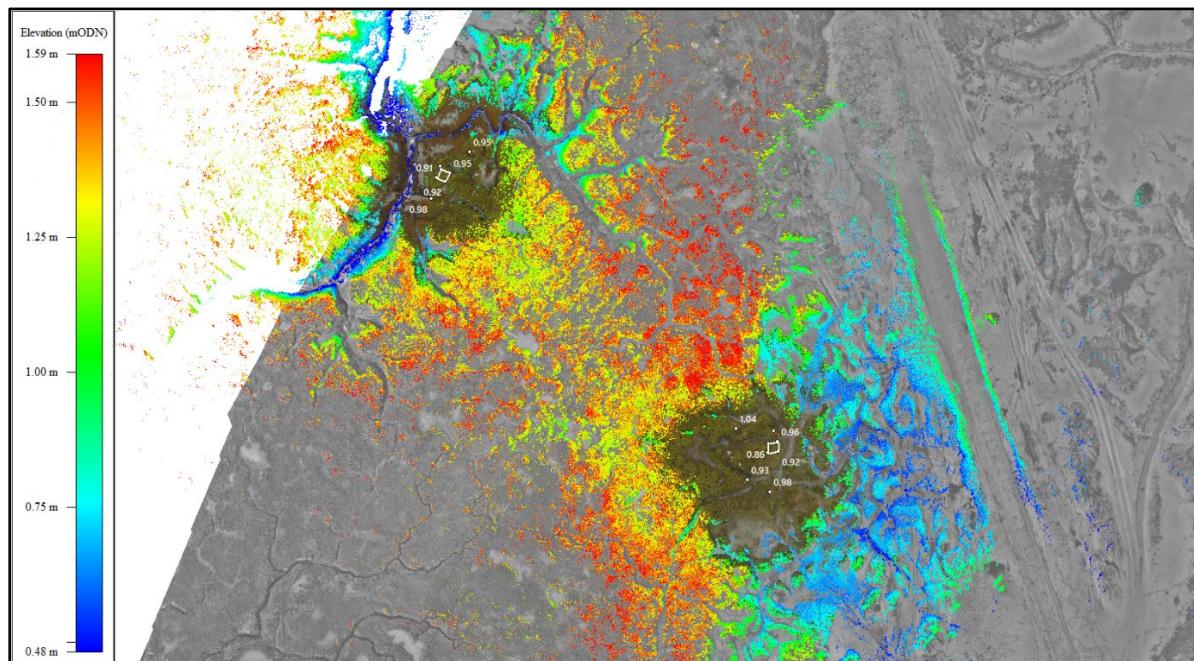
Image 7. GeoSLAM 3D LiDAR topography and photogrammetry at Sites Q2 and Q3

Finally, to provide some extra contextual information for this review and especially about the bed elevation across the survey site, Image 7 shows the outputs from the GeoSLAM LiDAR recording. Also, Figure 10 shows the extent of Boiler Marsh from Environment Agency 2022 LiDAR survey.

The GeoSLAM measurements were taken at Quadrat Sites Q2 and Q3 (see next section) to test this technique in this habitat. These measurements were useful for describing bed elevations at these sites in a new way and were used to verify other elevation readings for this study.

In future these localised readings may be useful for evaluating change. However, while the data had a small purpose here, and was visually interesting, this is not an approach which now needs to be adopted regularly in the future across this terrain. The best and most comprehensive information is still provided by using the Environment Agency LiDAR data (see Figure 10) and the project-specific bathymetry and UAV topography surveys. These techniques should continue to be a main element of the monitoring programme.

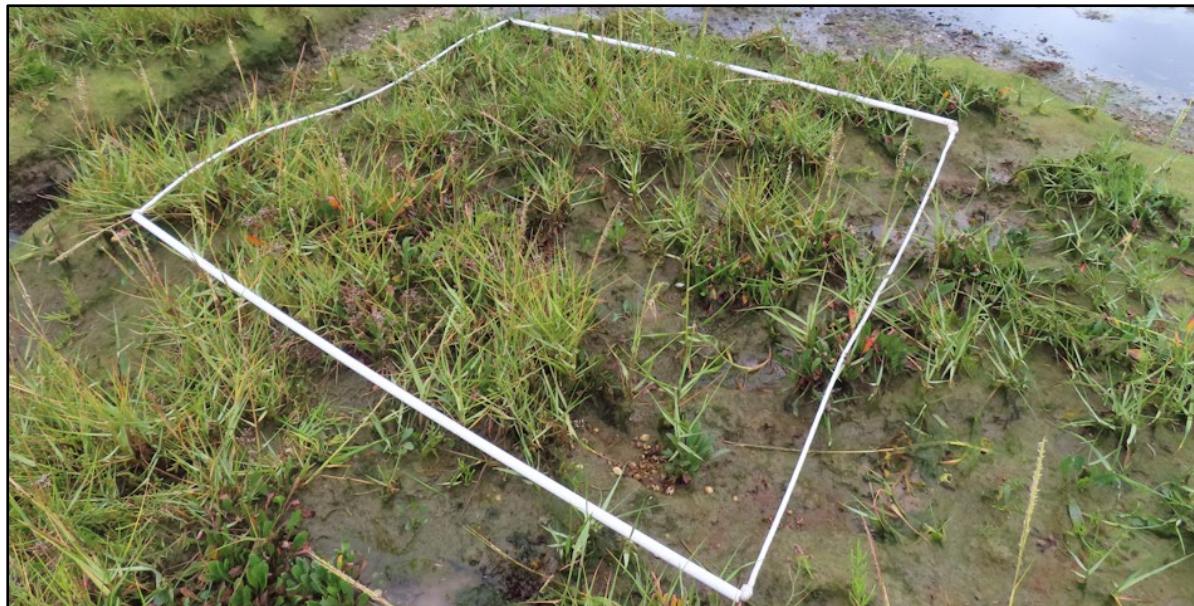
Image 8. Deteriorating internal marsh edge with mainly Spartina at Site Q2

situation and this change will reflect a process of ongoing internal marsh edge deterioration due to increasing tidal inundation, exposure and other physical and biological stresses.

- **Site Q2:** This is a relatively lower lying (at 0.92 m ODN) and exposed site that has shown signs of deterioration and decline in plant cover over just the two years between 2022 to 2004 (as described above);

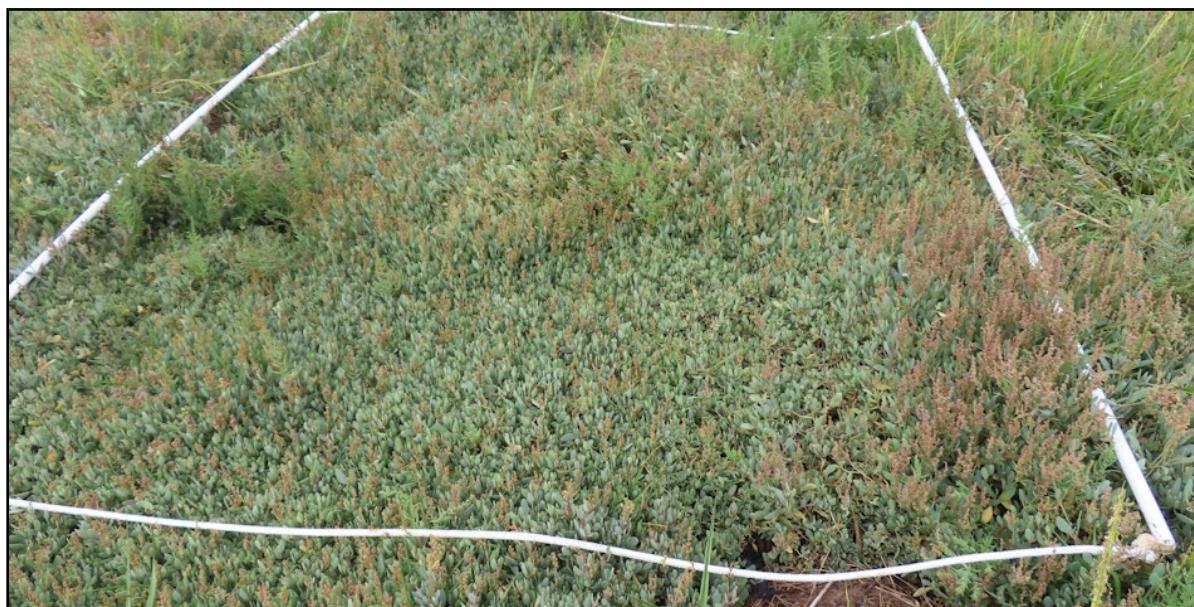
Image 9. Sea purslane dominated marsh at Site Q6

- **Site Q6:** This is the highest lying site (at 1.24 m ODN⁶) and because it lies next to a channel it is well drained and characterised by sea purslane⁷. This habitat is ideally suited for nesting waterbirds, and one of last season's nests lies at the edge of the quadrat (see Image 9);
- **Site Q7.** This site has the greatest range of species (seven recorded in 2024 and, like Q6, a dense 100% coverage of plants. It is similar in elevation to Q4 (at 1.05 m ODN) which again shows the value of even modest increase in bed elevation relative the exposed marsh fringes.

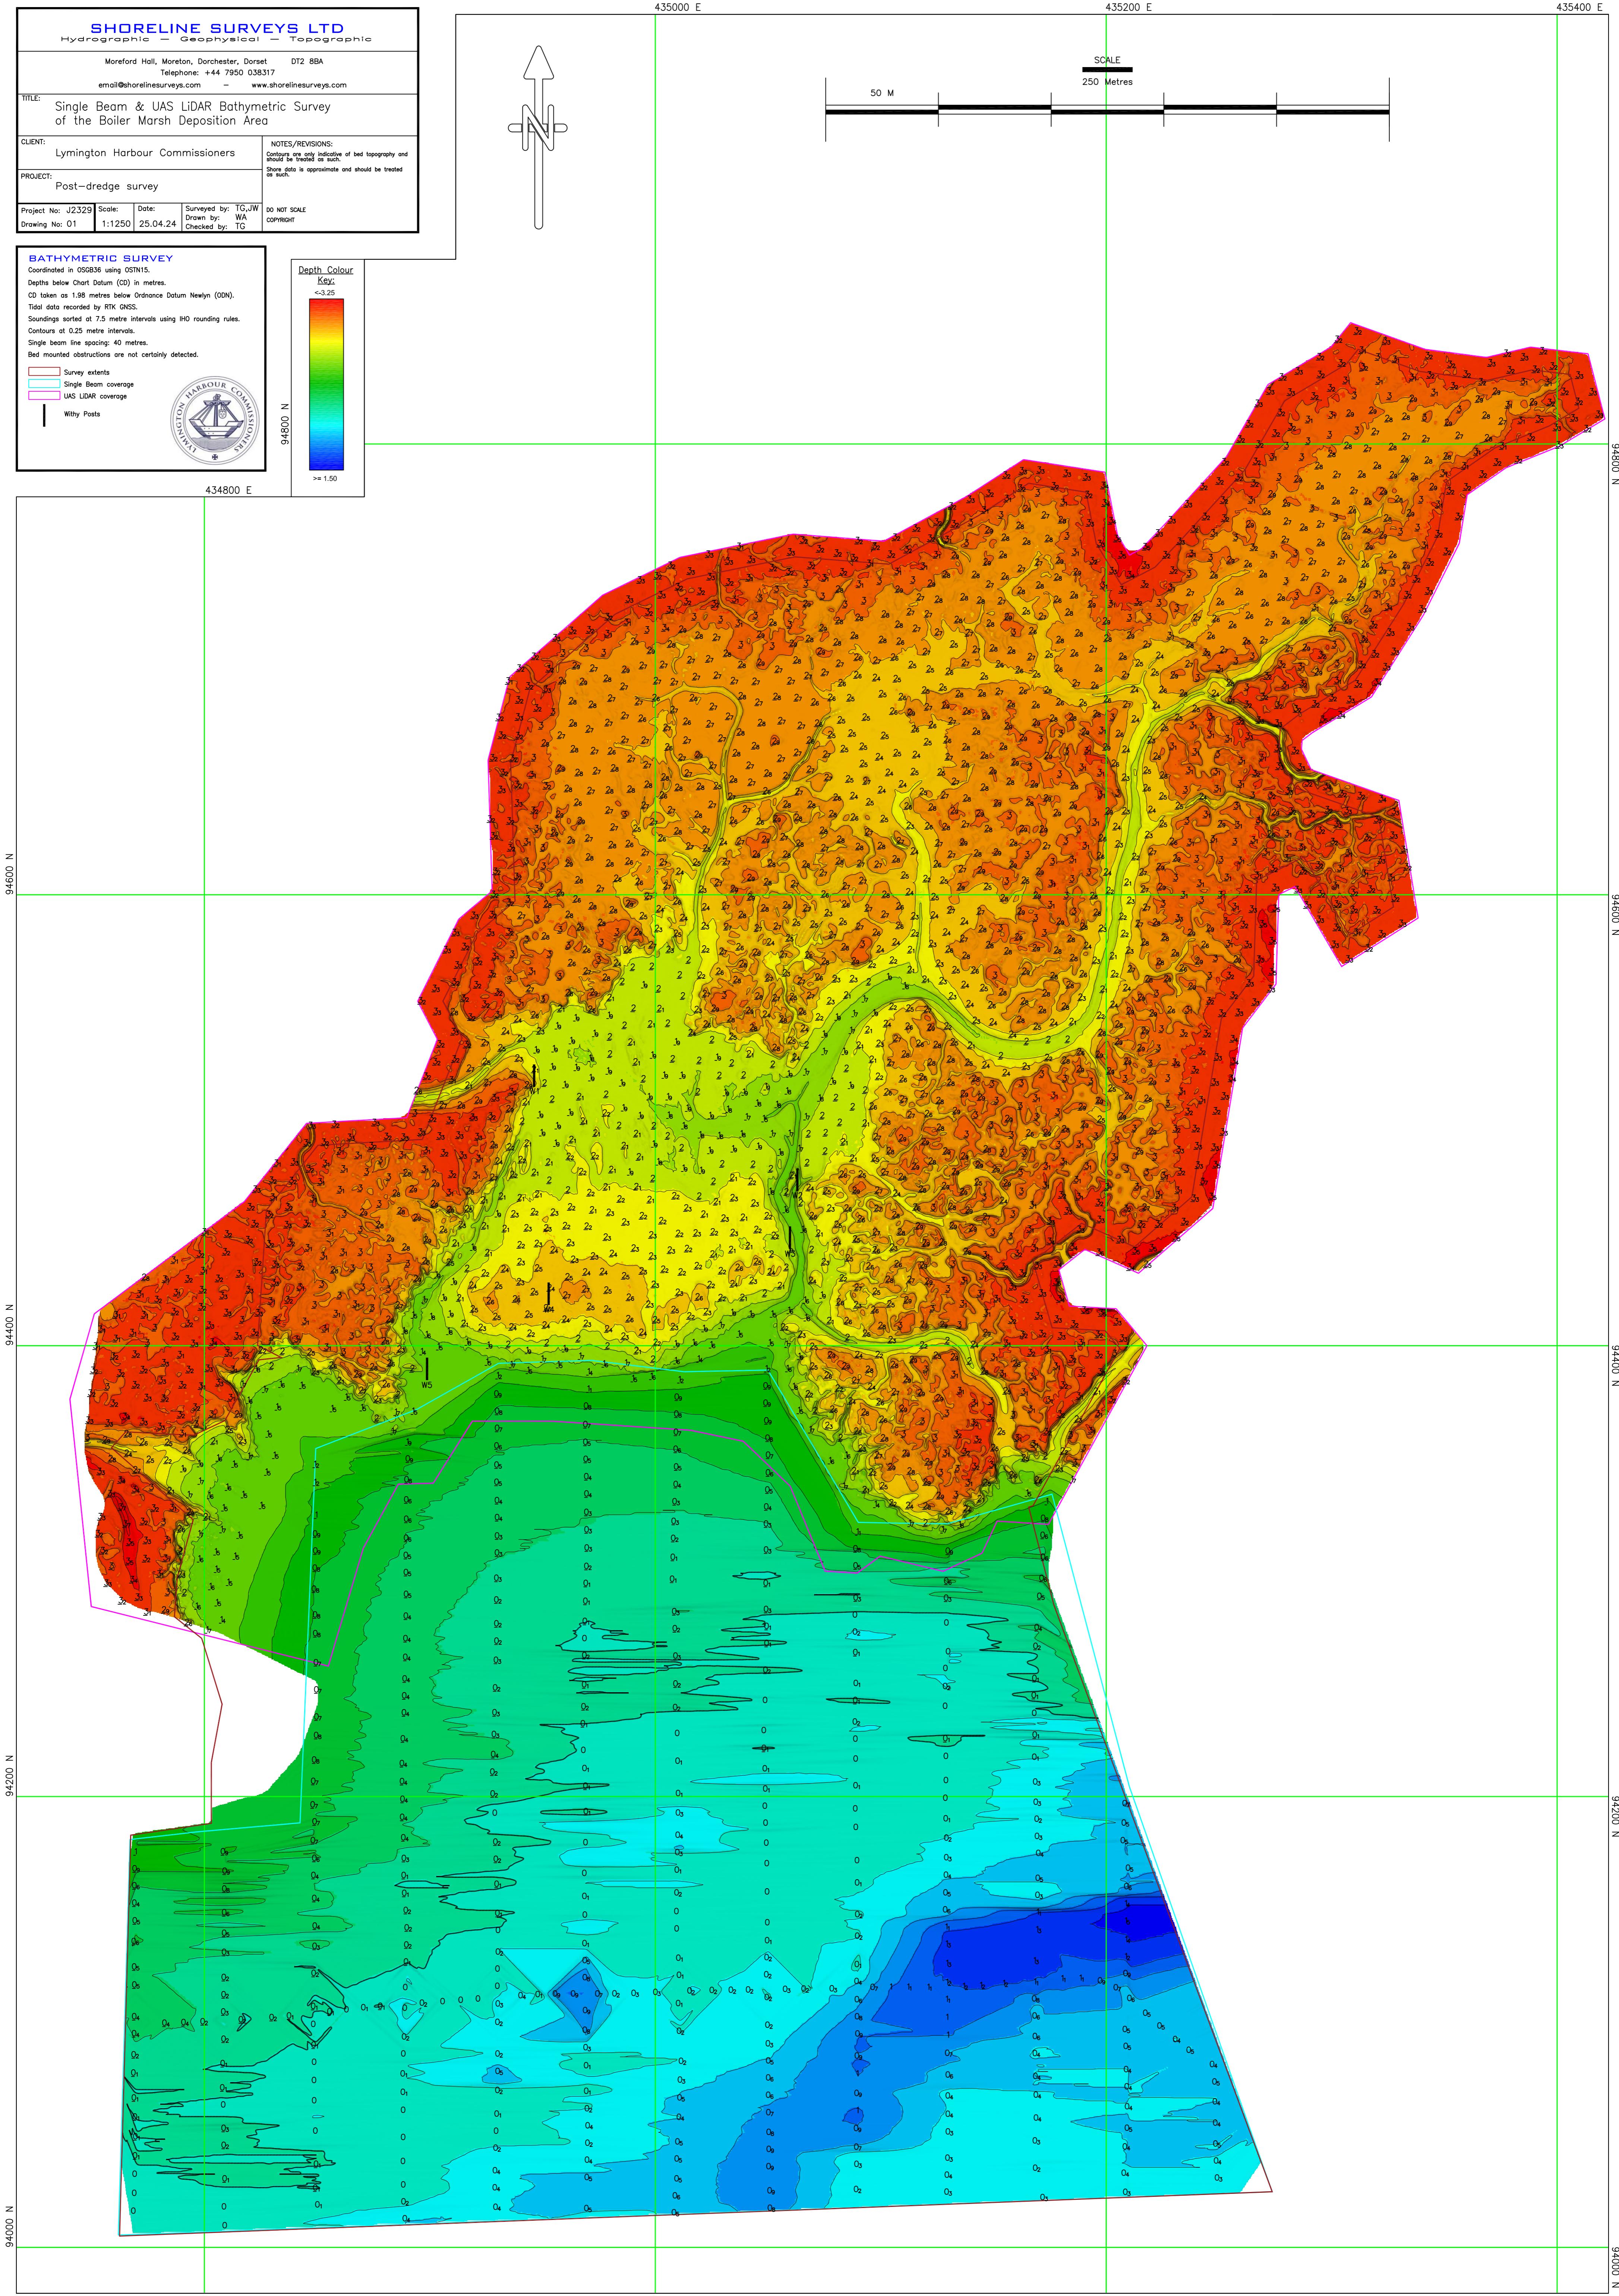
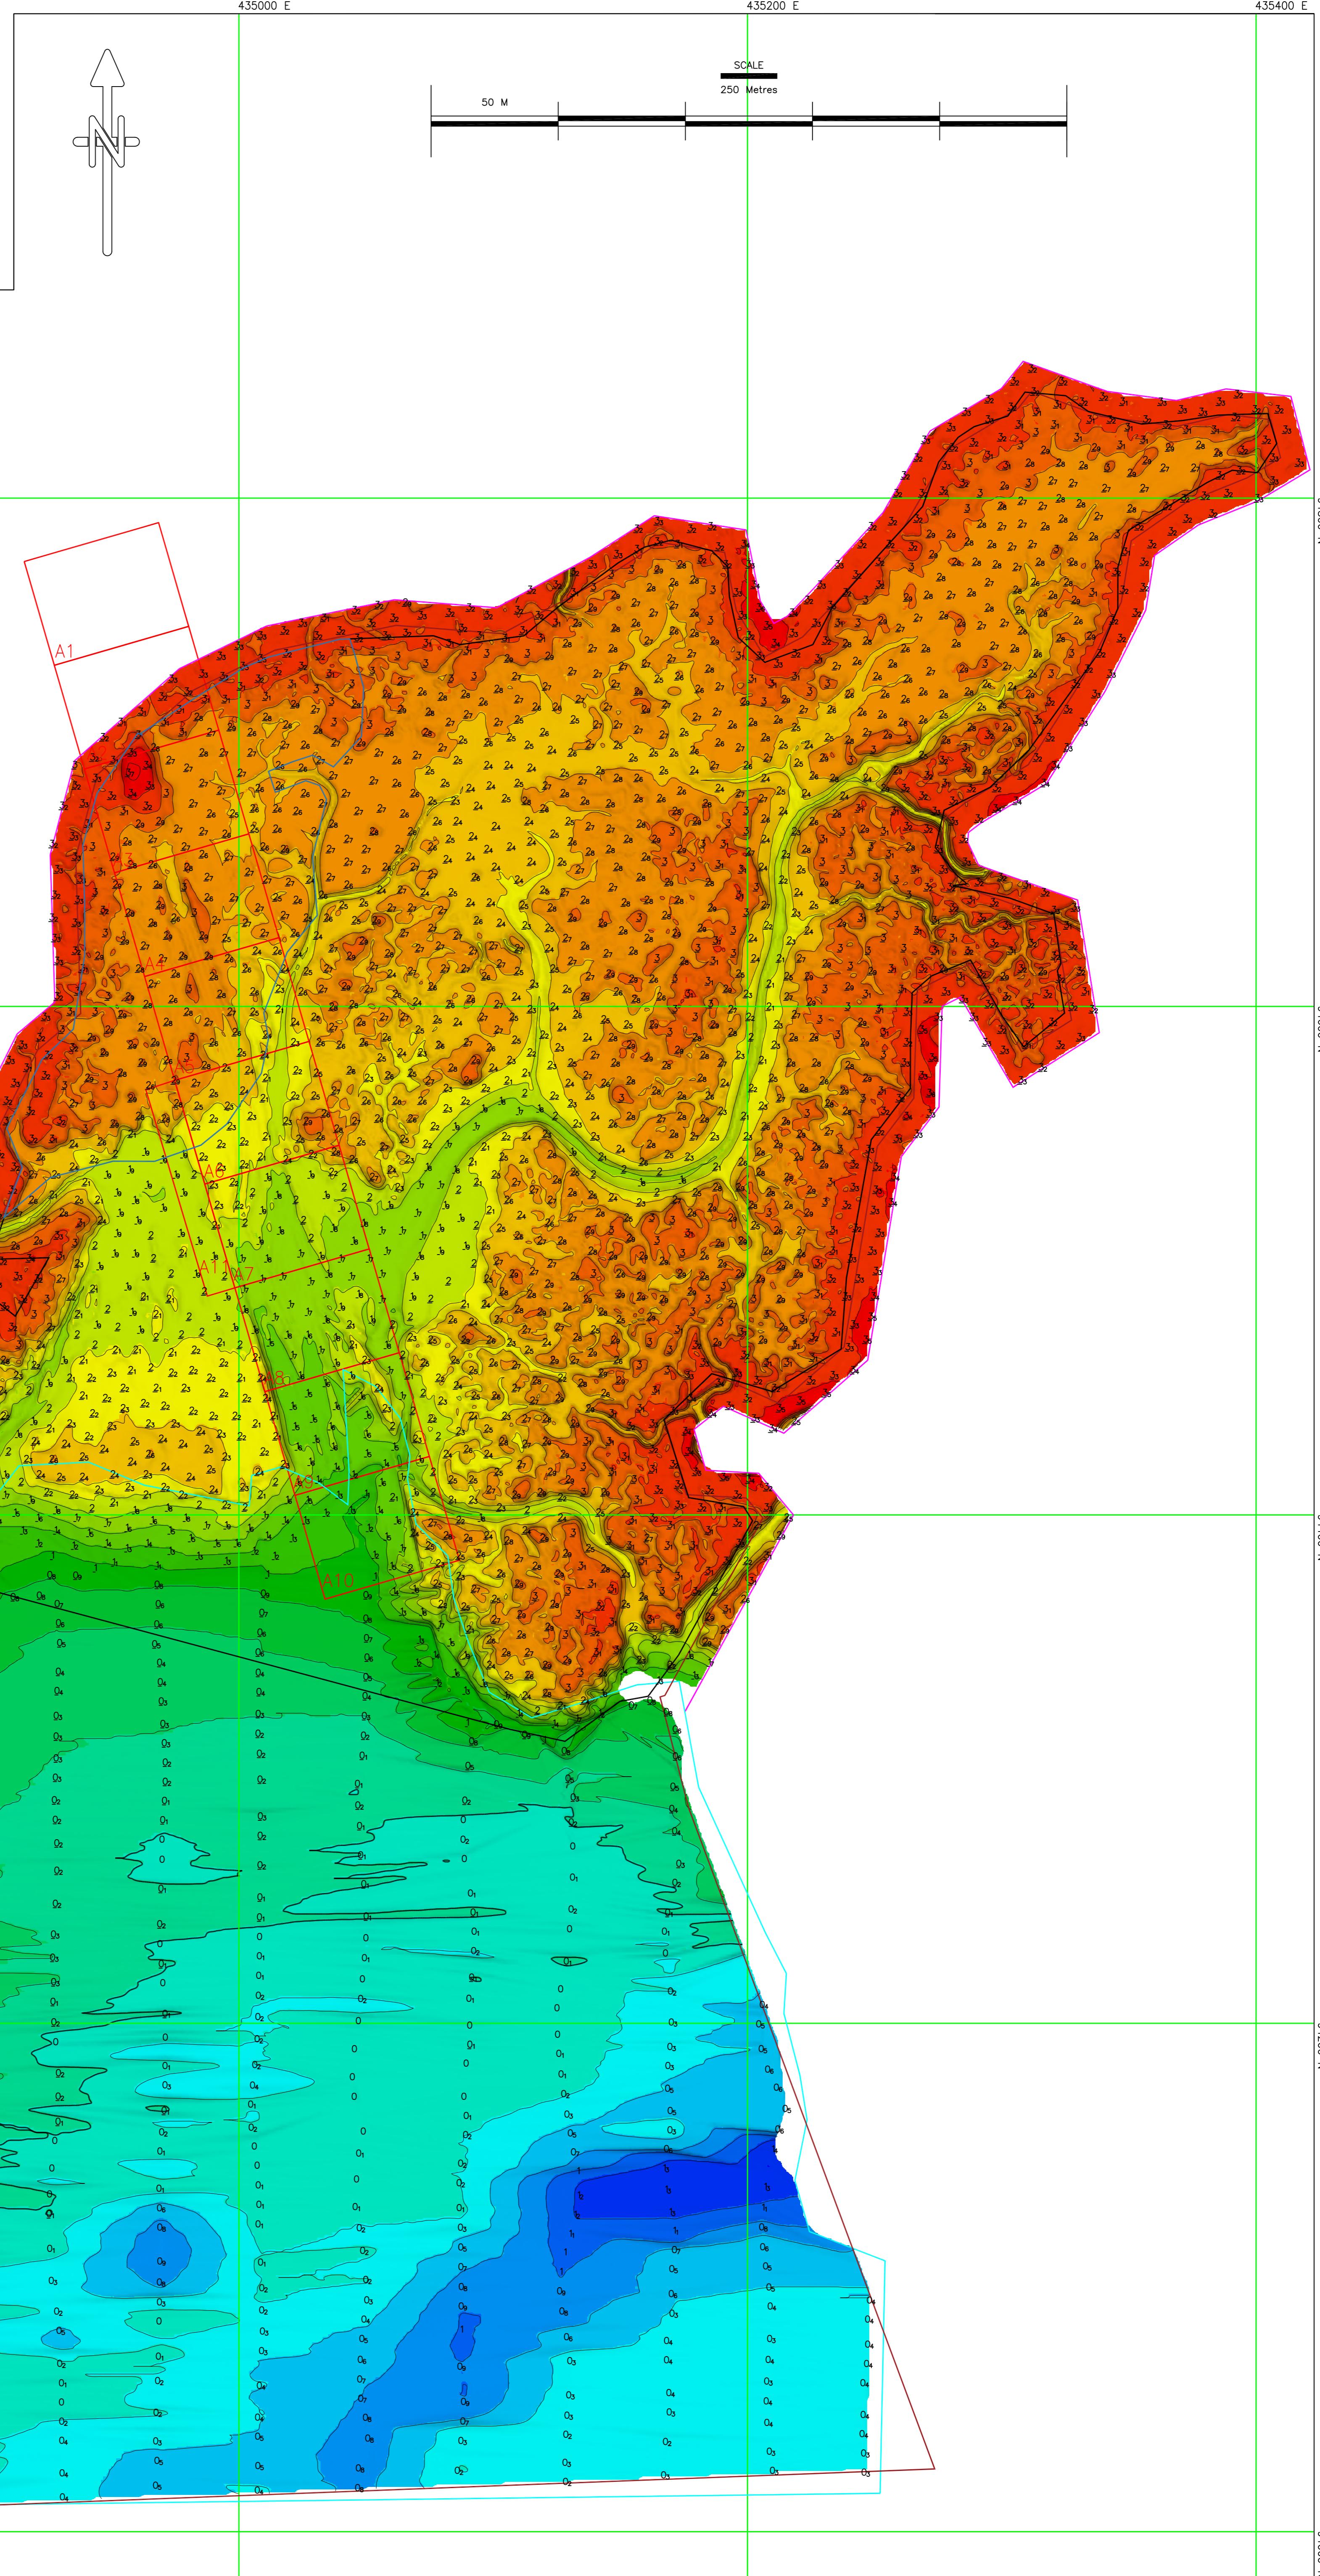
This appendix includes two detailed bed elevation maps of the Boiler Marsh restoration area and dredge sediment placement zone. These maps were produced by Shoreline Surveys Ltd following surveys they conducted (on behalf of LHC and LAWS) before the restoration work on 25 April 24 and then immediately after it on 02 October 2024.

These two maps (Map 1 and Map 2) were created by combining data from boat-based bathymetric and UAV-derived topographic surveys on each occasion. The areas covered by these surveys are illustrated in Figure 6 within the covering report and Figure 7 of the report illustrates the main bed elevation changes between them.
